the play inspection company

Annual Inspection

Pendle Borough Council

Salterforth

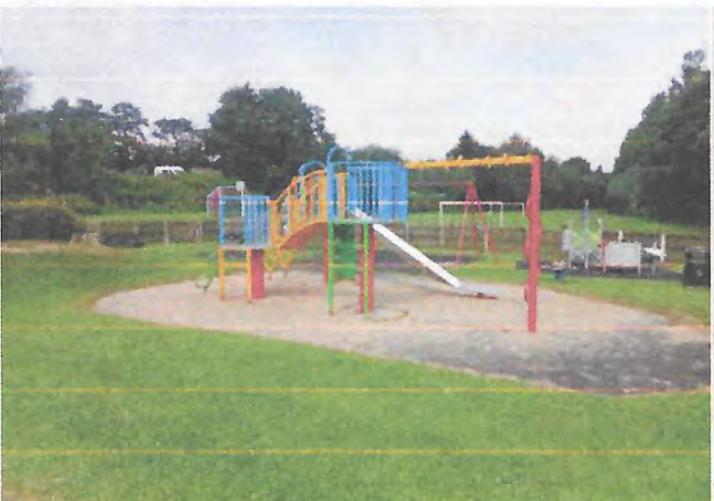
Finding: Sand has migrated on to the surfaces	Action: Clean and maintain

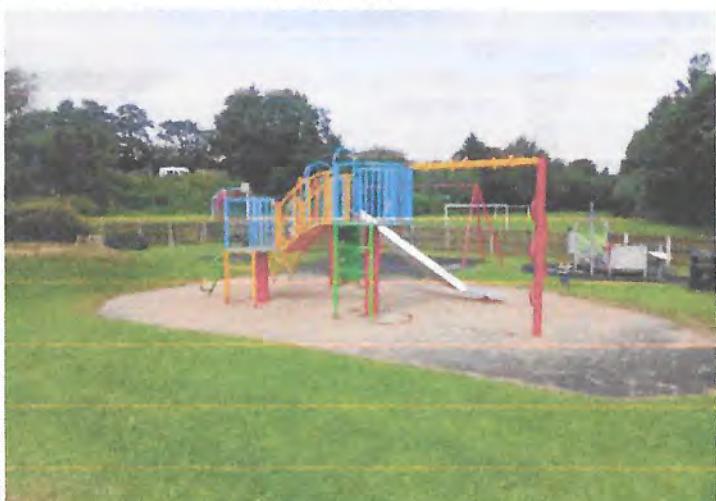
Finding: There is weed / vegetation growth on, between, or around the edges of the surfacing **Action:** Remove weed / vegetation growth

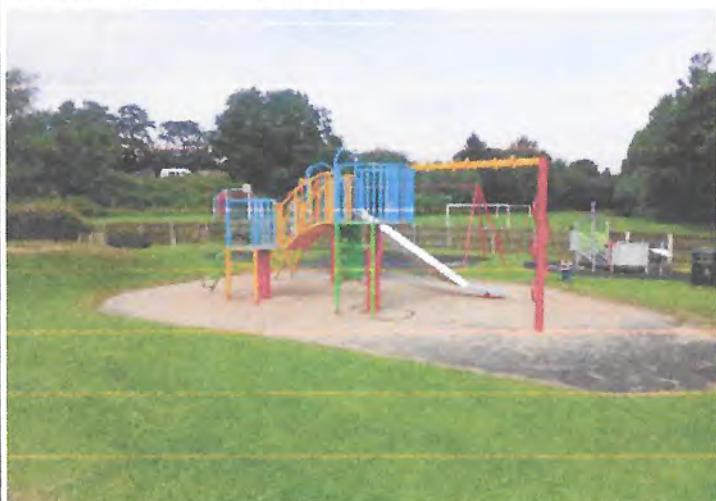
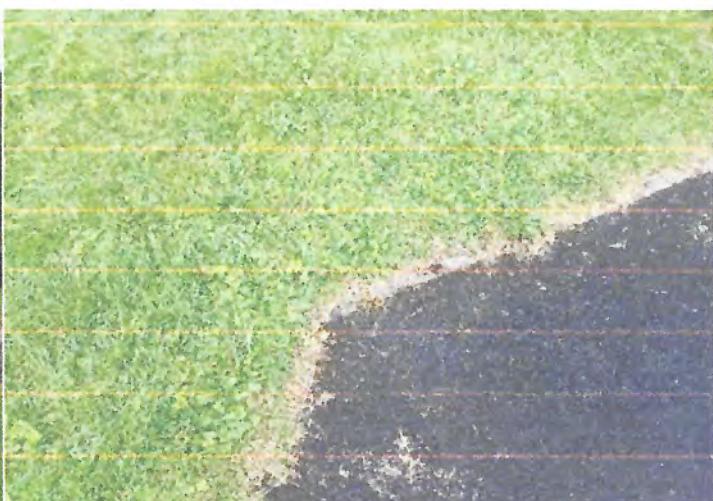
Finding: There is algae, silt or moss growth on the surface resulting in slippery conditions **Action:** Clean and treat appropriately

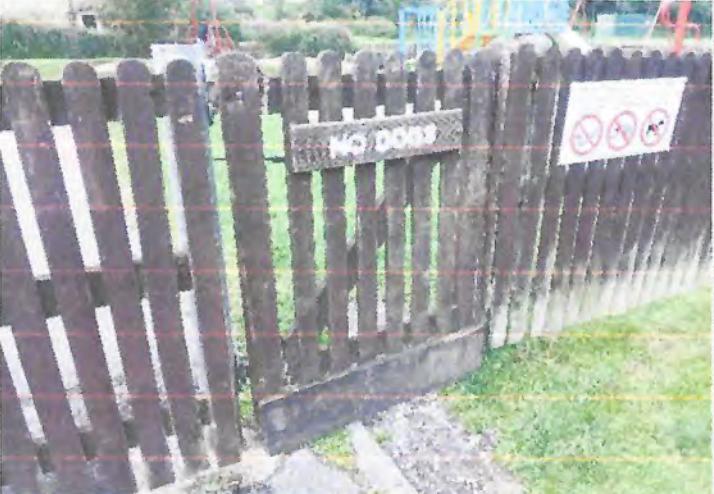
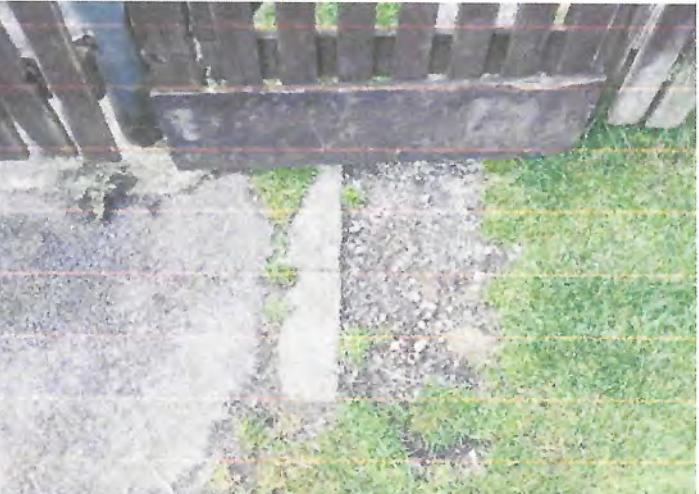
8 - Low Risk (Finding 1)			
Item:	Gates - Gate - Self Closing	Risk Level:	L - Low Risk
Manufacturer:	Not Identified	Surface:	Bitmac

Finding: The area under the gate has eroded leaving uneven areas, or the concrete foundations exposed, resulting in trip hazards at the entrance/exit to the playground	
Action: Reinstate to level with surrounding surfaces

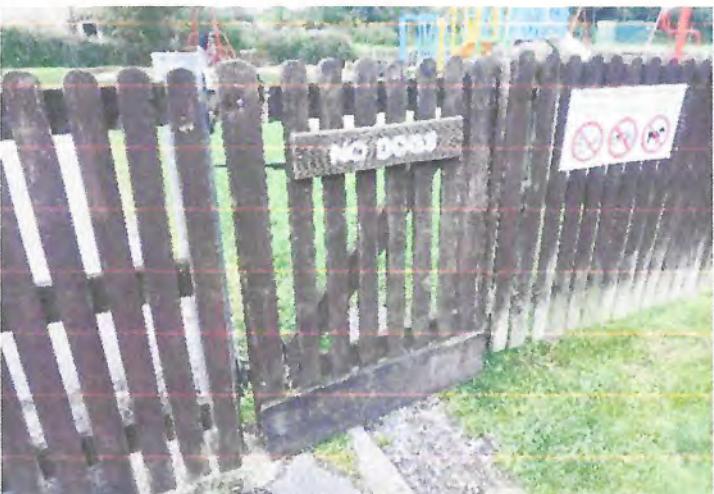
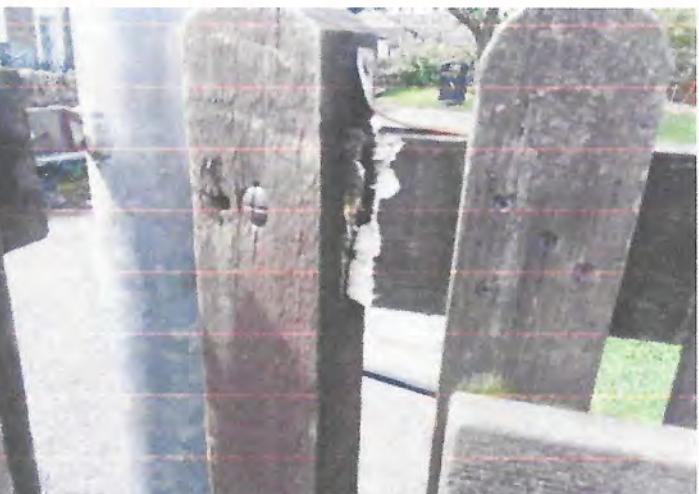
6 - Low Risk (Finding 2)			
Item:	Gates - Gate - Self Closing	Risk Level:	L - Low Risk
Manufacturer:	Not Identified	Surface:	Bitmac

Finding: The item has been damaged	
Action: Monitor for any further deterioration and replace as required

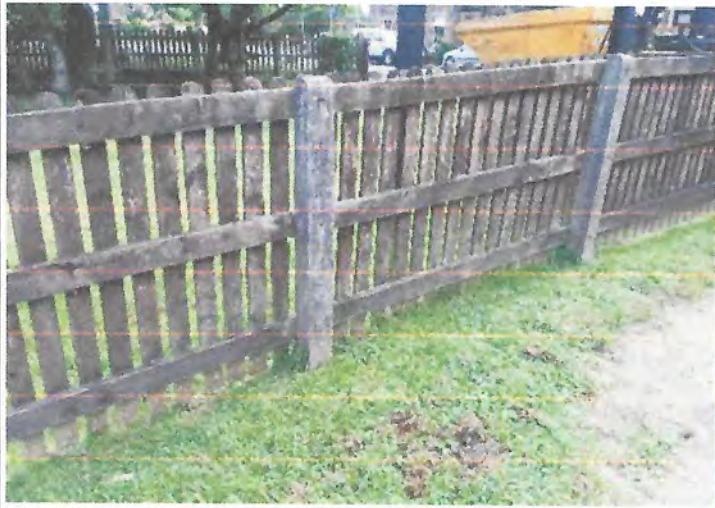
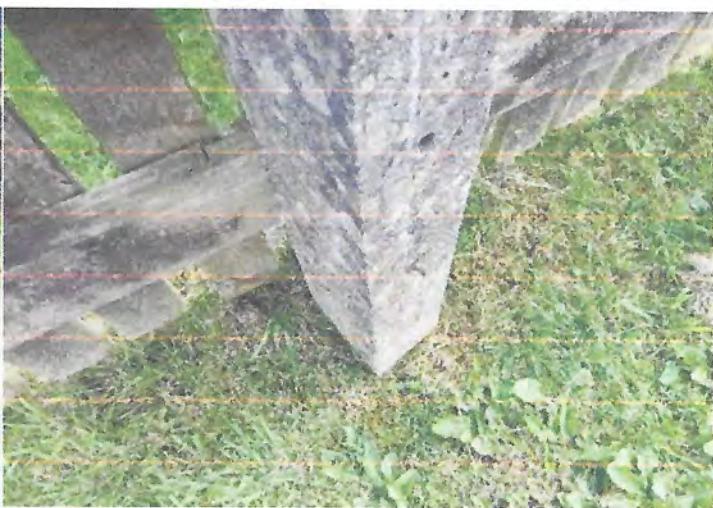
Finding: There are projecting bolt thread(s) present

Action: Remove excess thread length and deburr or provide cap

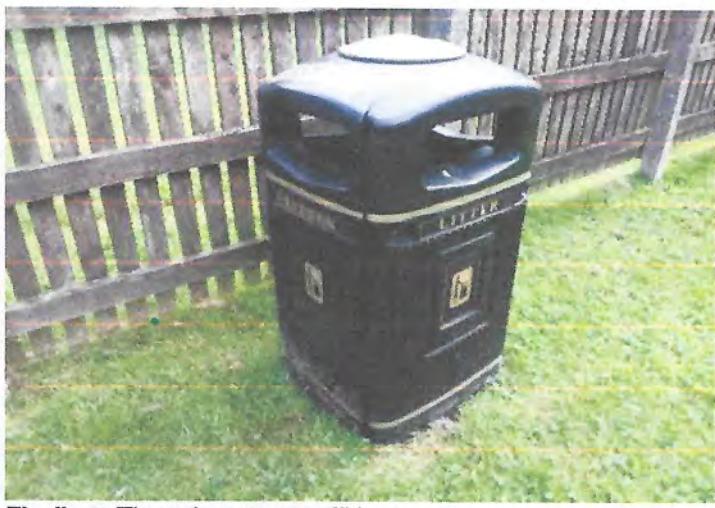
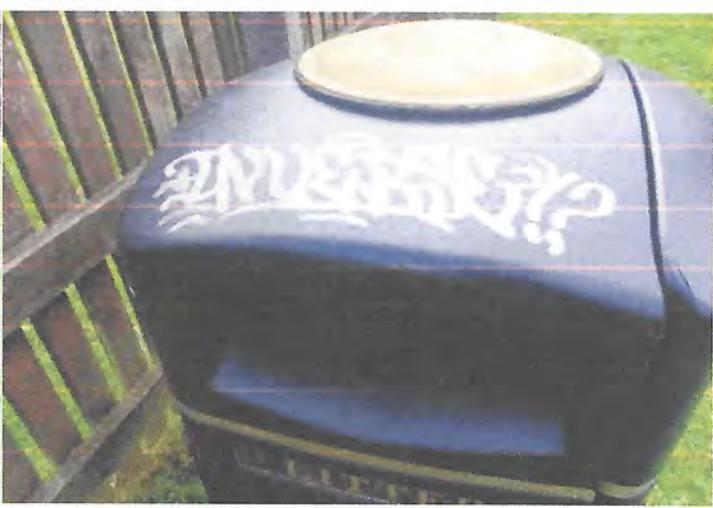
Finding: There is some graffiti present

Action: Remove the graffiti

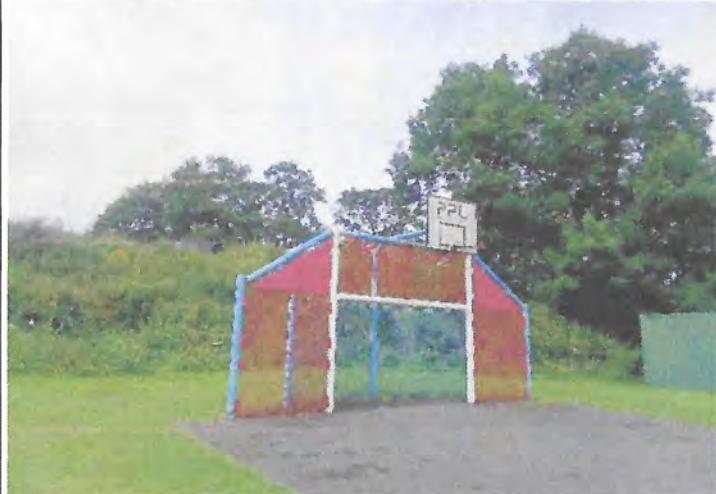
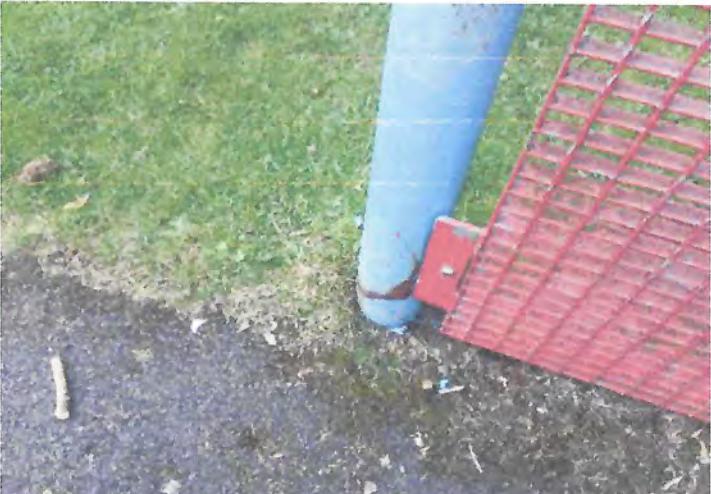
Finding: The paintwork on this item has been damaged or worn exposing the metal underneath which is rusting / corroding

Action: Treat affected areas and repaint

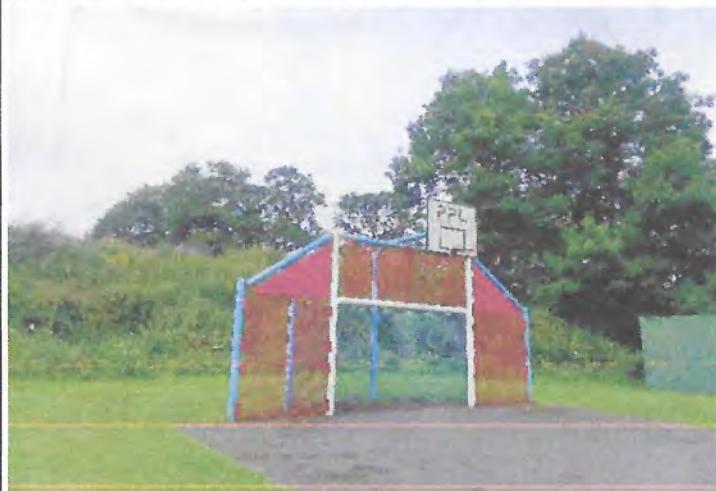
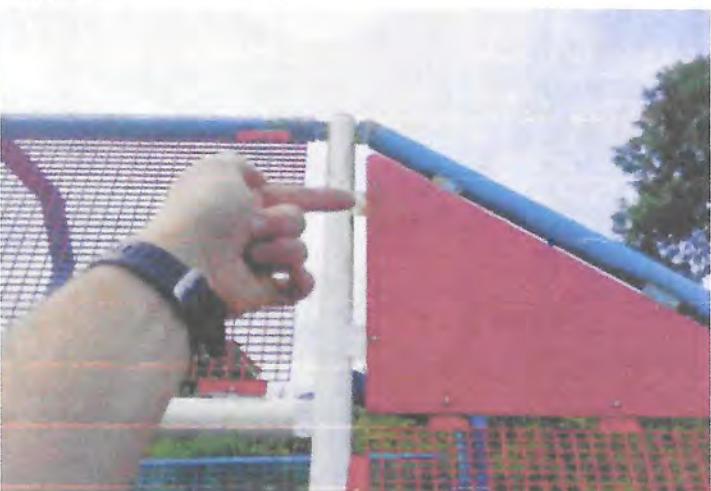
Finding: There is or are fixings missing on the item

Action: Replace all missing fixings

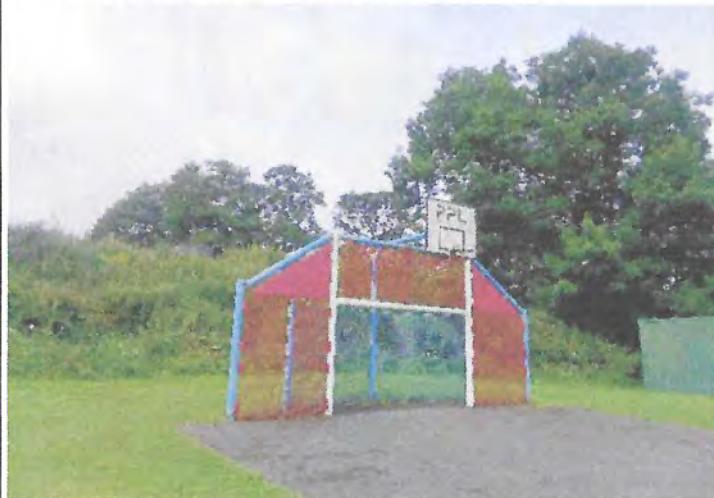
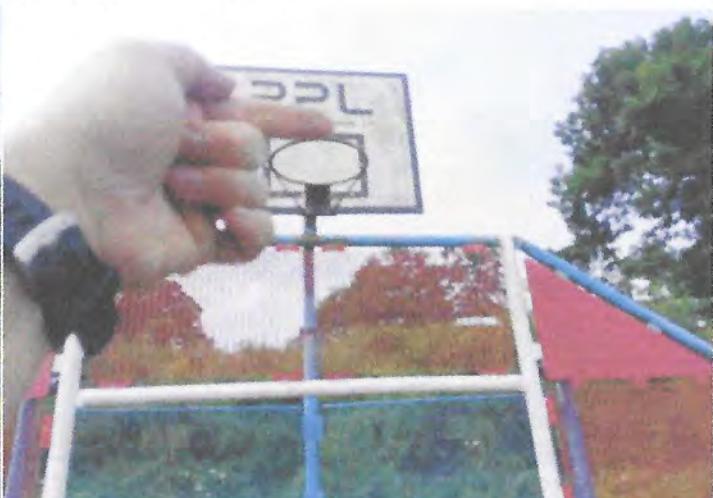
Finding: There is or are fixings missing on the backboard

Action: Replace all missing fixings

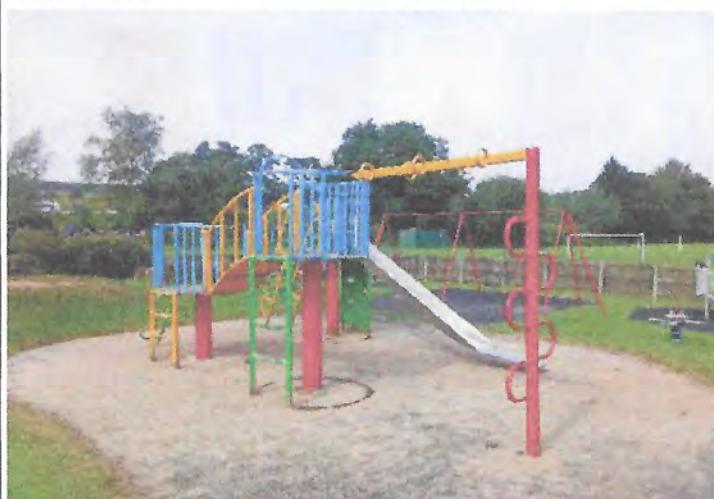
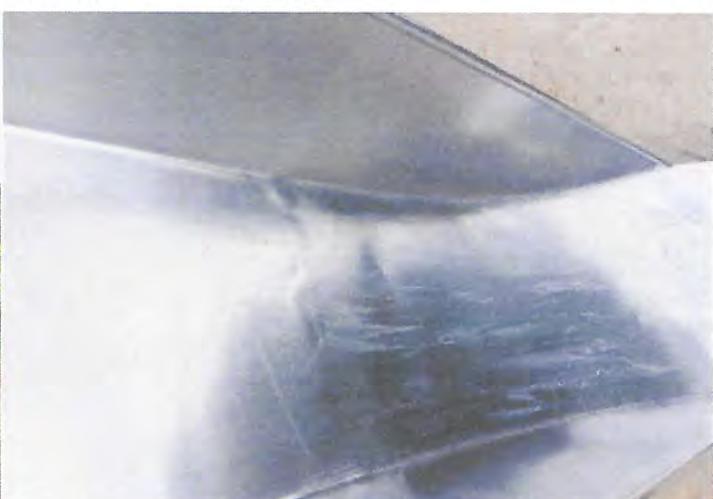
Finding: There are a number of dents in the slide surface

Action: Monitor for any further deterioration and repair as required

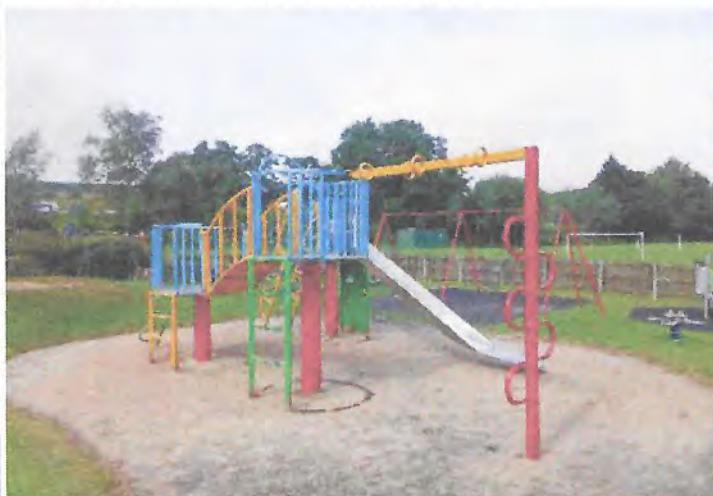
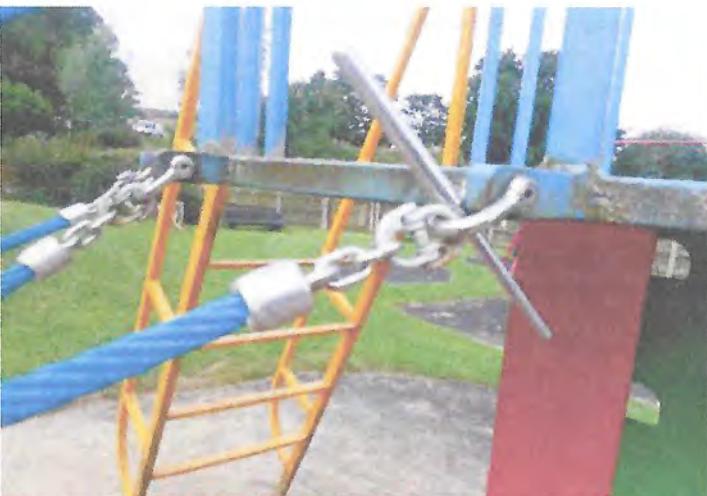
Finding: The connecting links are in excess of 8.6mm and less than 12mm and fail the requirements of BS EN 1176 Part 1; clause 4.2.13, Chains

Action: Monitor use and replace with compliant links at the next maintenance cycle

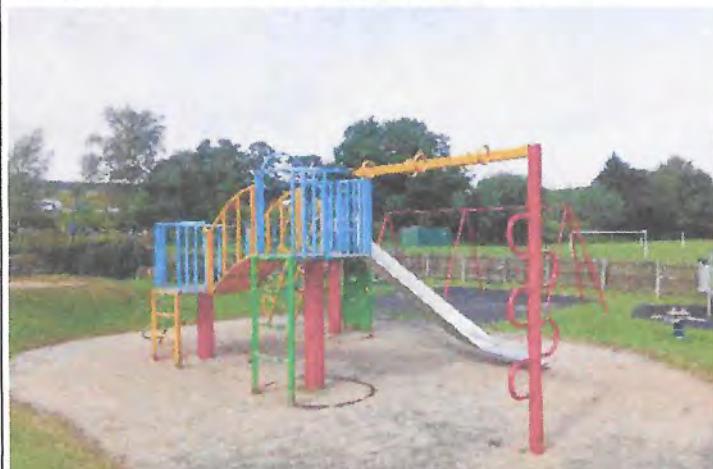
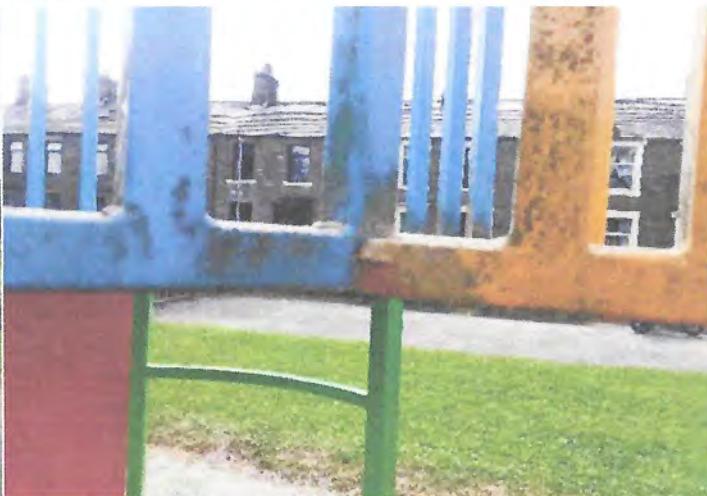
Finding: The paintwork on this item has been damaged or worn exposing the metal underneath which is rusting / corroding

Action: Treat affected areas and repaint

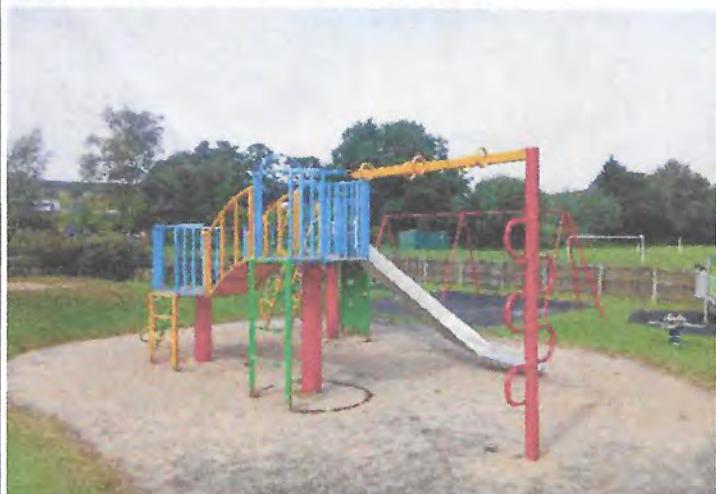
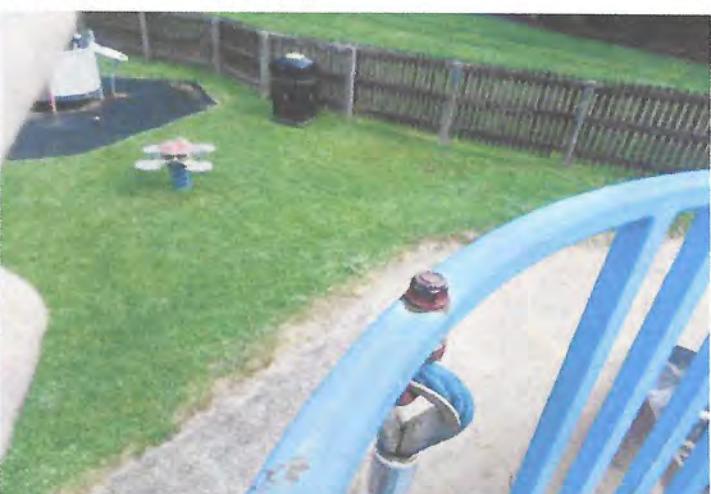
Finding: There is/are bolt cap covers missing or damaged on the item

Action: Replace missing or damaged bolt cap covers

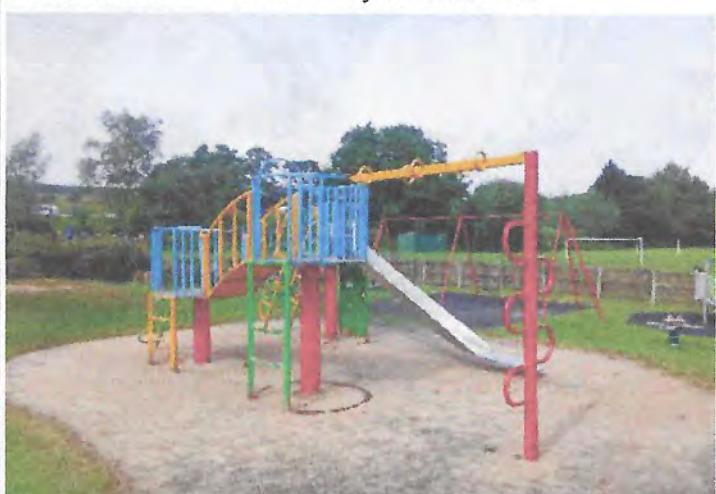
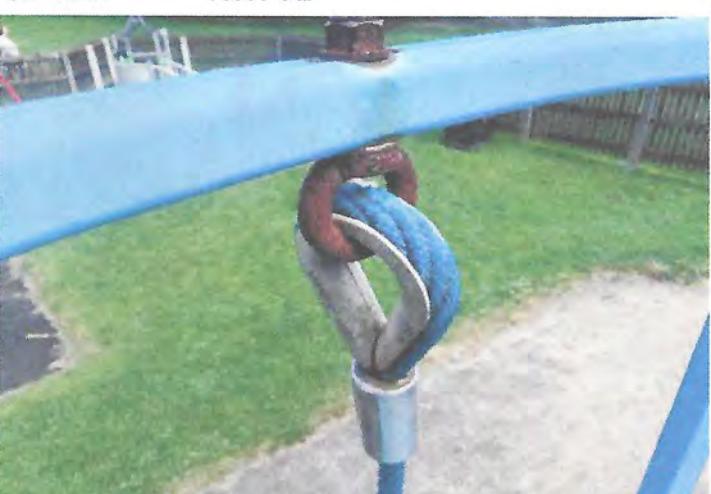
Finding: The ropes/nets are worn/damaged in places

Action: Monitor for any further deterioration and repair or replace as required

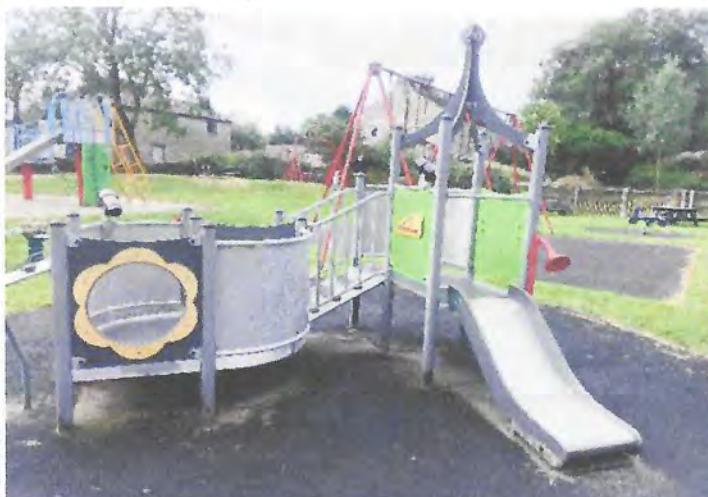
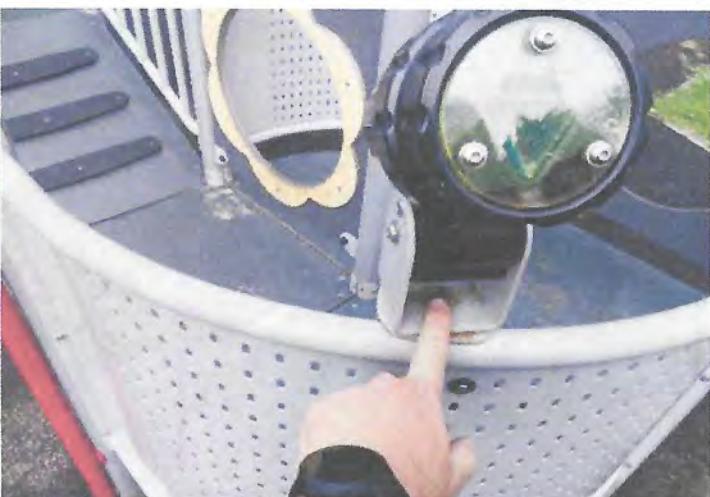
Finding: A number of fixing(s) have worked loose

Action: Secure all loose fixings

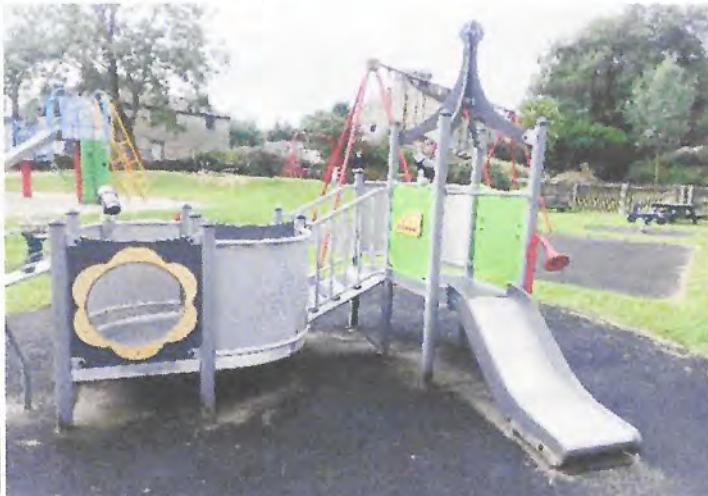
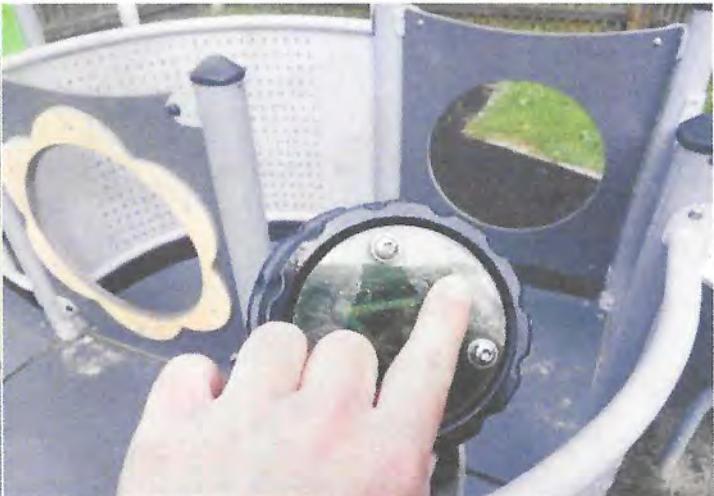
Finding: The item has been damaged

Action: Monitor for any further deterioration and replace as required

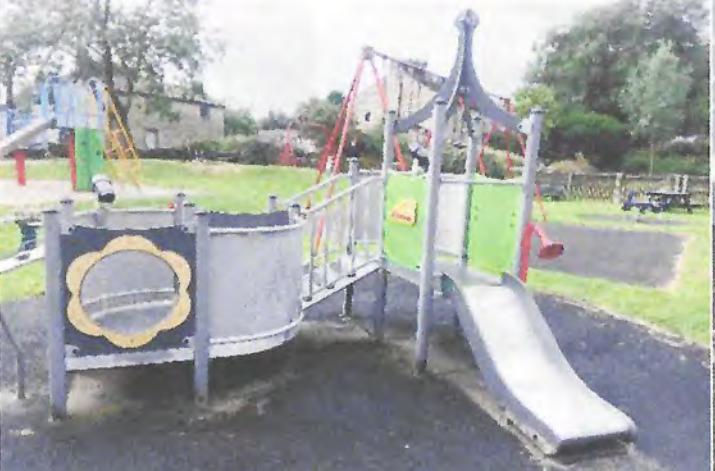
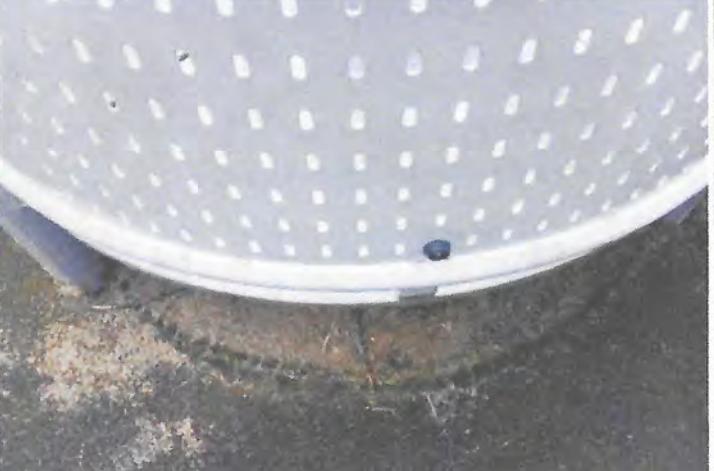
4 - Very Low Risk (Finding 5)	Item: Activity Equipment - Multi Play (Toddler) Manufacturer: Hags	Risk Level: V - Very Low Risk Surface: Wet Pour

Finding: There is/are bolt cap covers missing or damaged **Action:** Replace missing or damaged bolt cap covers on the item

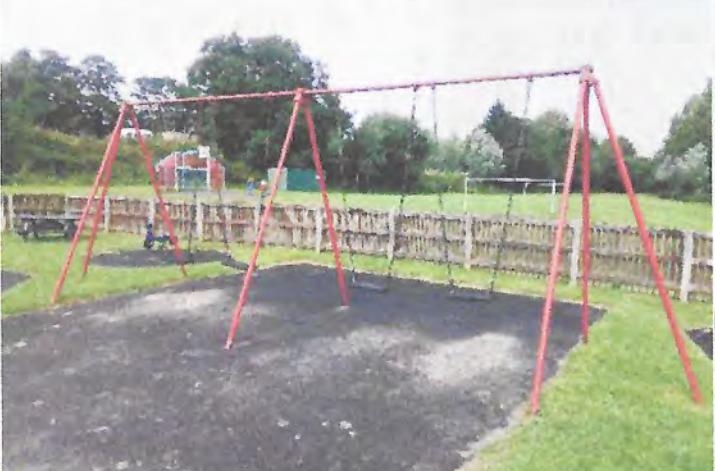
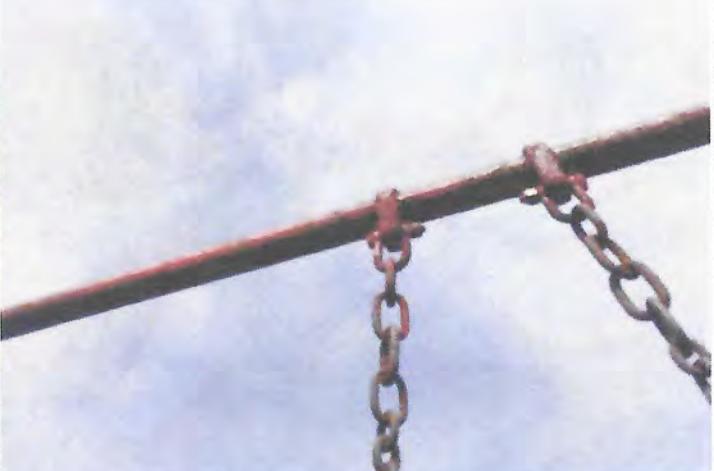
8 - Low Risk (Finding 1)	Item: Swings - 2 Bay 4 Seat (Flat) Manufacturer: Wicksteed Playgrounds	Risk Level: L - Low Risk Surface: Wet Pour

Finding: The bushes are worn or missing **Action:** Replace worn or missing bushes

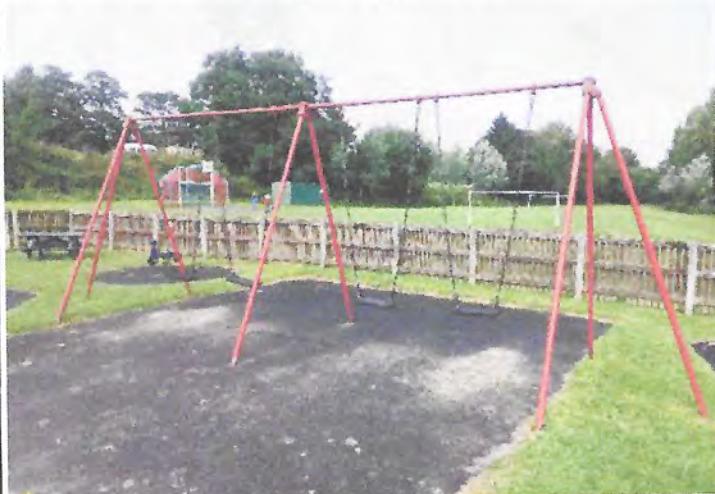
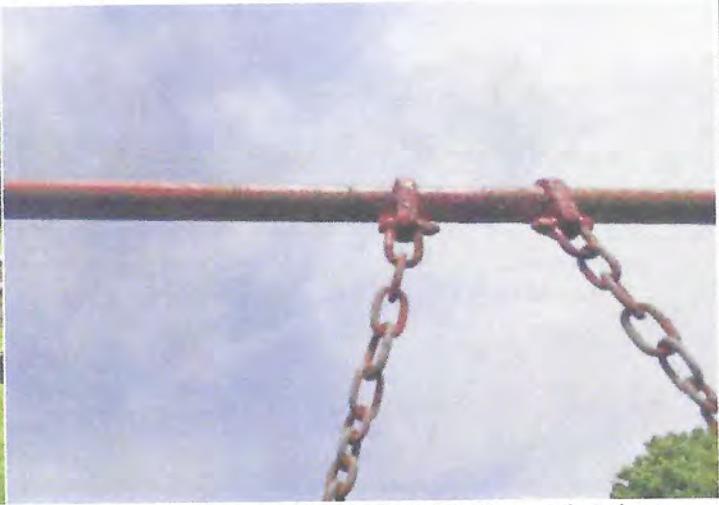
Finding: There is some wear to the shackles

Action: Monitor for any further deterioration and replace when 40% worn

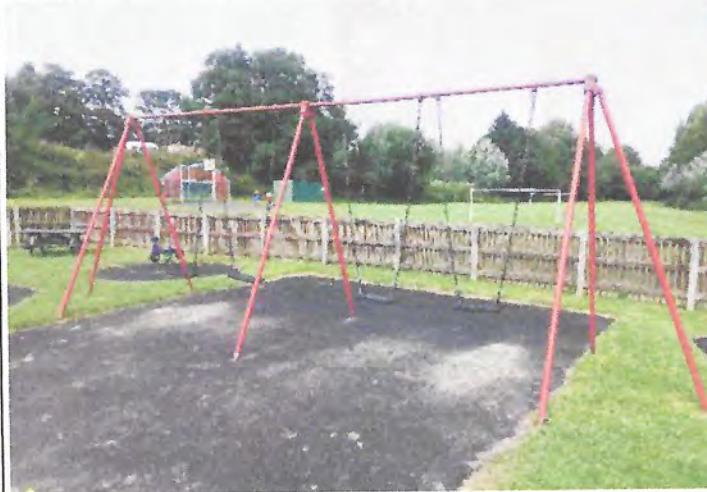
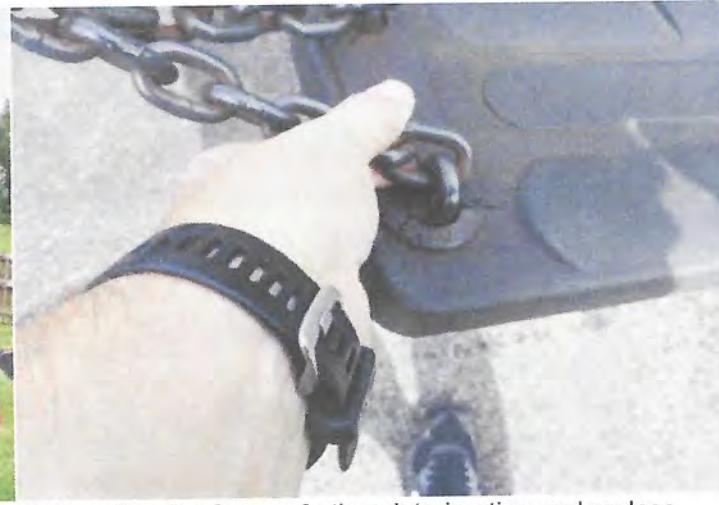
Finding: There is some notable evidence of chain wear

Action: Monitor for any further deterioration and replace when 40% worn

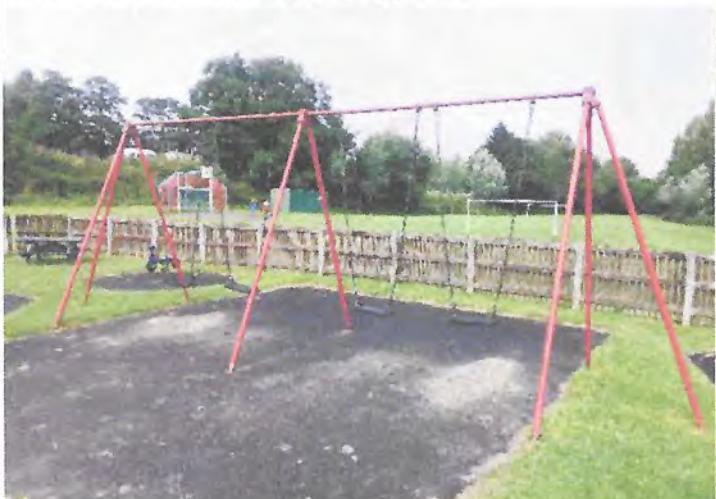
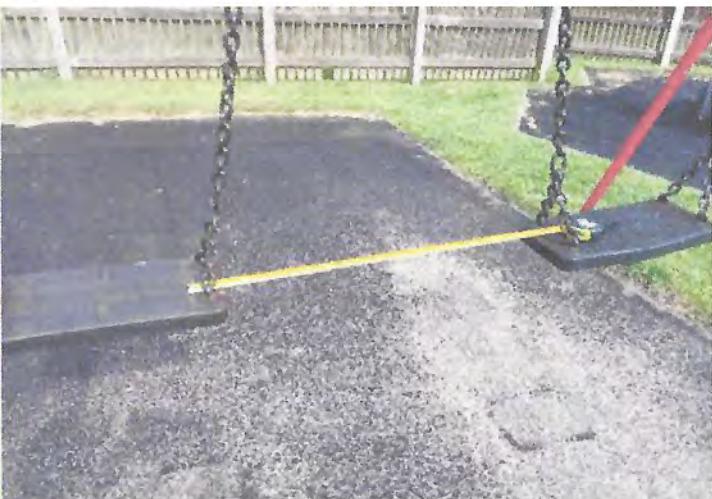
Finding: The seats are too close to each other as defined in **Action:** Monitor - No remedial work recommended
 BS EN 1176 Part 2; this is a low risk failure and no remedial action is required

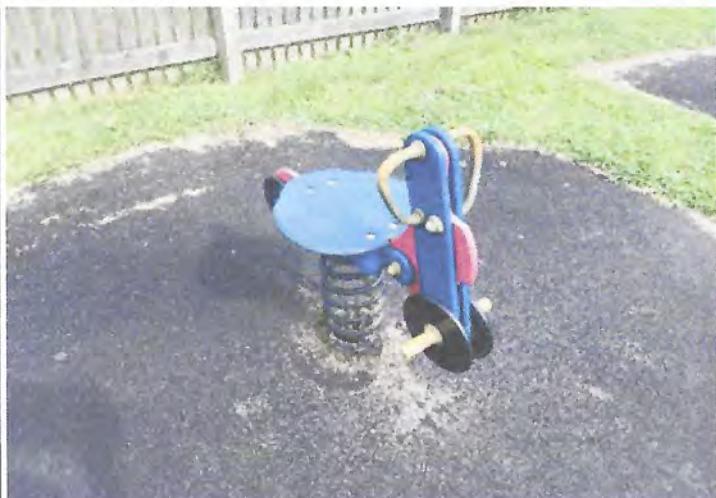
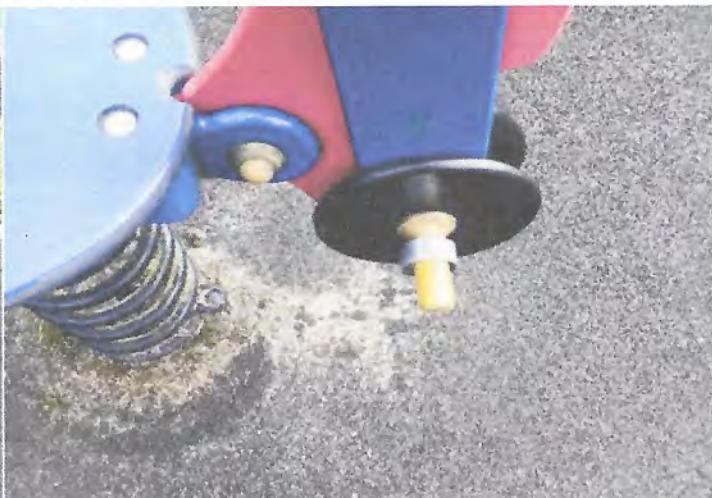
Finding: The end of handgrips and/or footrests have a cross section of less than 15cm² and fail to meet the requirements of BS EN 1176 Part 6
Action: Monitor - No remedial work recommended

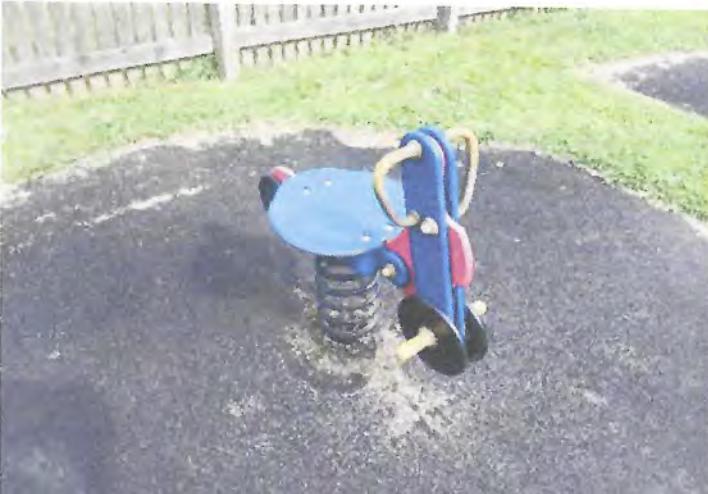
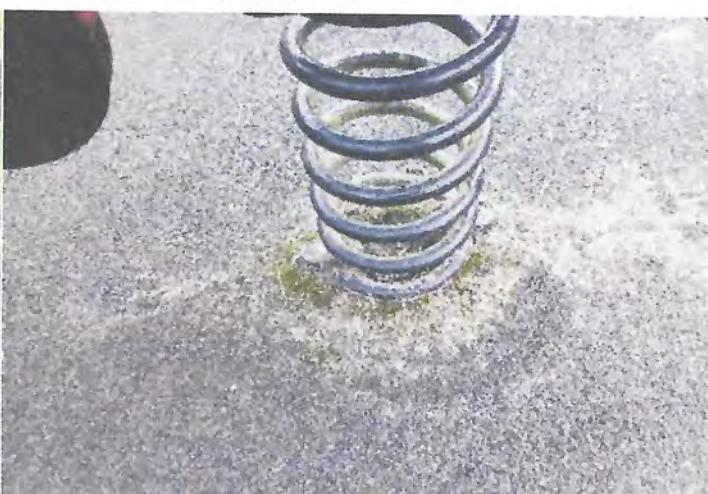
4 - Very Low Risk (Finding 2)	
Item: Rocking Equipment - Spring Bike Manufacturer: Ledon	Risk Level: V - Very Low Risk Surface: Wet Pour

Finding: The U bolts clamping the spring are worn	Action: Monitor for any further deterioration and replace as required

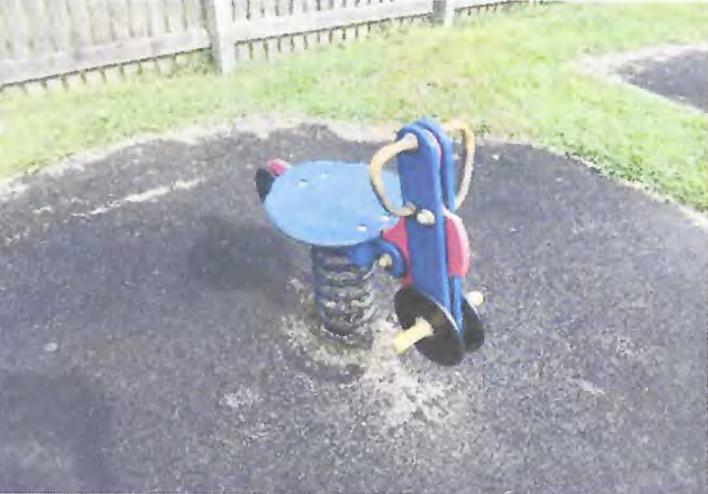
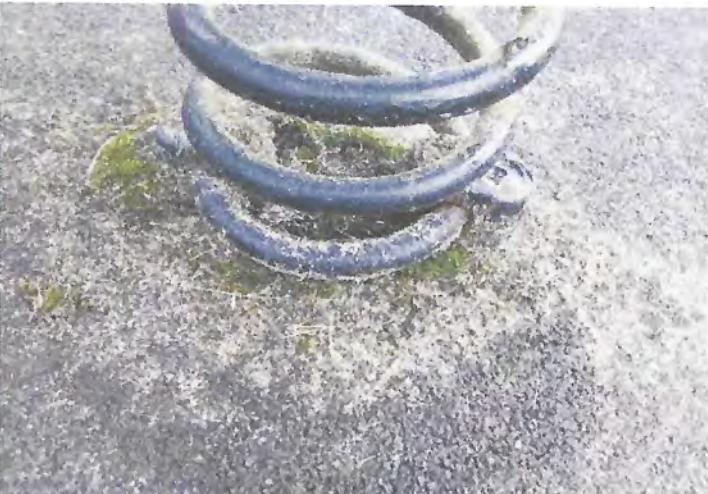
6 - Low Risk (Finding 3)	
Item: Rocking Equipment - Spring Bike Manufacturer: Ledon	Risk Level: L - Low Risk Surface: Wet Pour

Finding: The paintwork on the spring has been damaged or worn exposing the metal underneath which is rusting	Action: Treat any rusting components and repaint

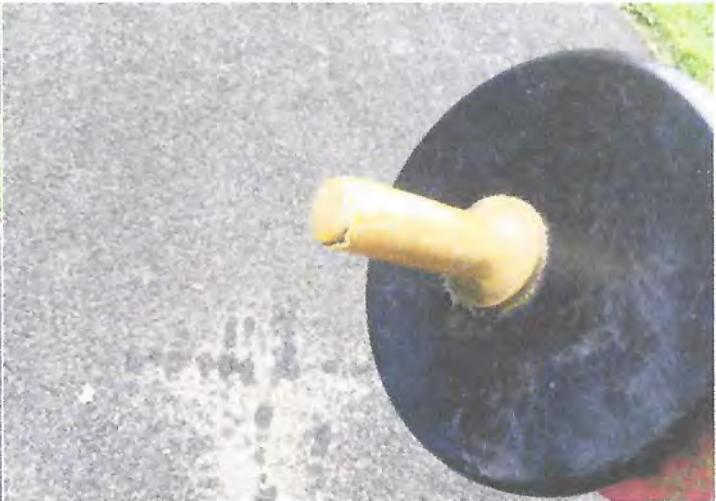
Finding: The footrest has been damaged

Action: Monitor for any further deterioration and replace as required

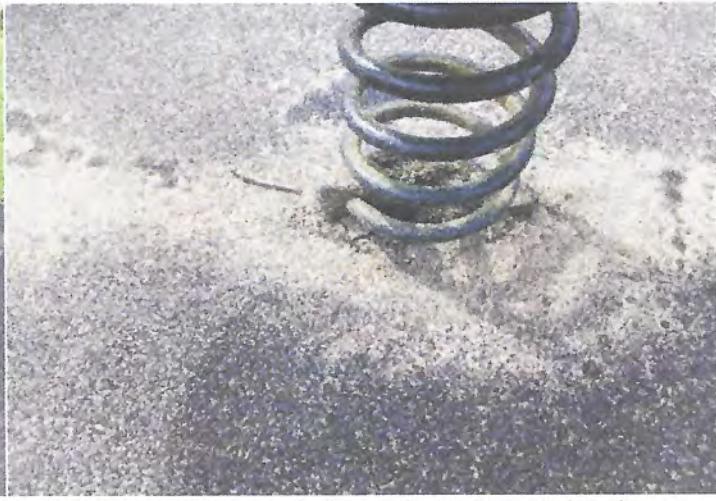
Finding: The U bolts clamping the spring are worn

Action: Monitor for any further deterioration and replace as required

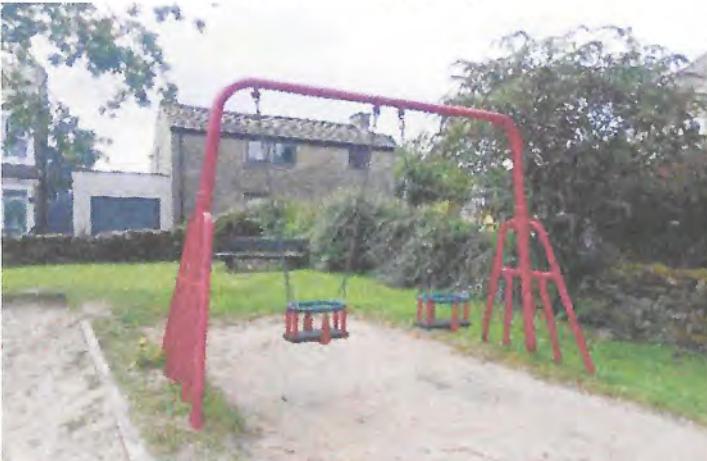
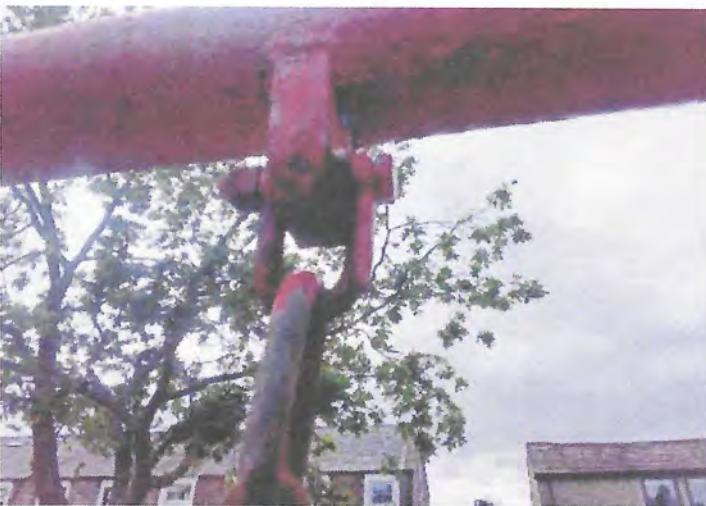
4 - Very Low Risk (Finding 1)	
Item: Swings - 1 Bay 2 Seat (Cradle) Manufacturer: Wicksteed Playgrounds	Risk Level: V - Very Low Risk Surface: Wet Pour

Finding: The bushes are showing signs of wear	Action: Monitor for any further deterioration and replace as required

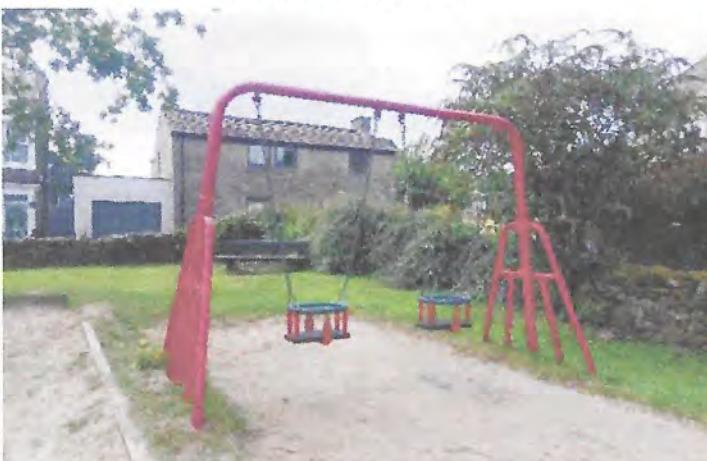
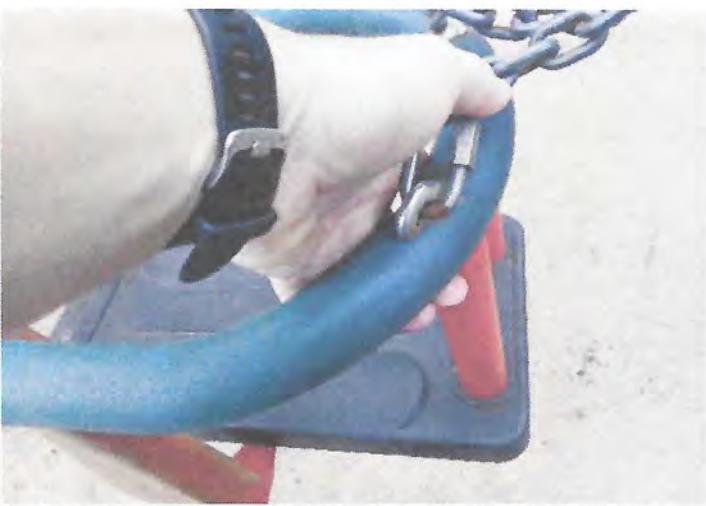
6 - Low Risk (Finding 2)	
Item: Swings - 1 Bay 2 Seat (Cradle) Manufacturer: Wicksteed Playgrounds	Risk Level: L - Low Risk Surface: Wet Pour

Finding: There is some wear to the shackles	Action: Monitor for any further deterioration and replace when 40% worn

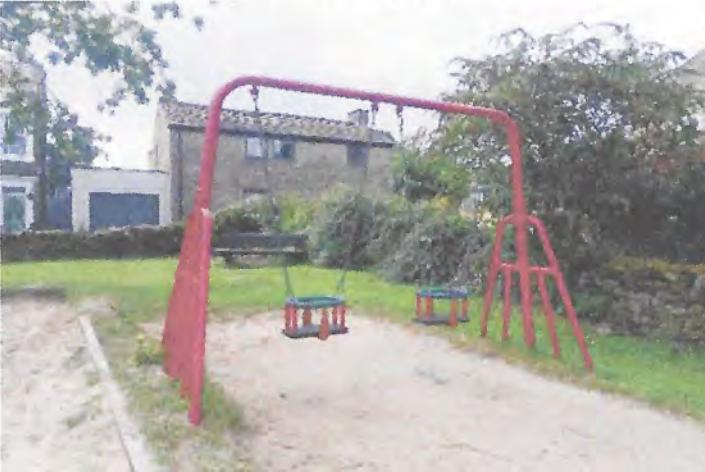
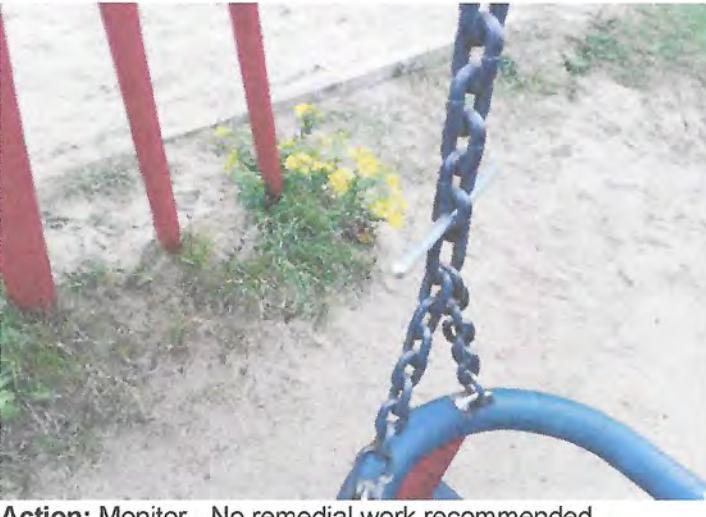
5 - Very Low Risk (Finding 3)	
Item: Swings - 1 Bay 2 Seat (Cradle)	Risk Level: V - Very Low Risk
Manufacturer: Wicksteed Playgrounds	Surface: Wet Pour

Finding: The chain openings are in excess of 8.6mm and do not meet the recommendations of BS EN 1176 Part 1	Action: Monitor - No remedial work recommended

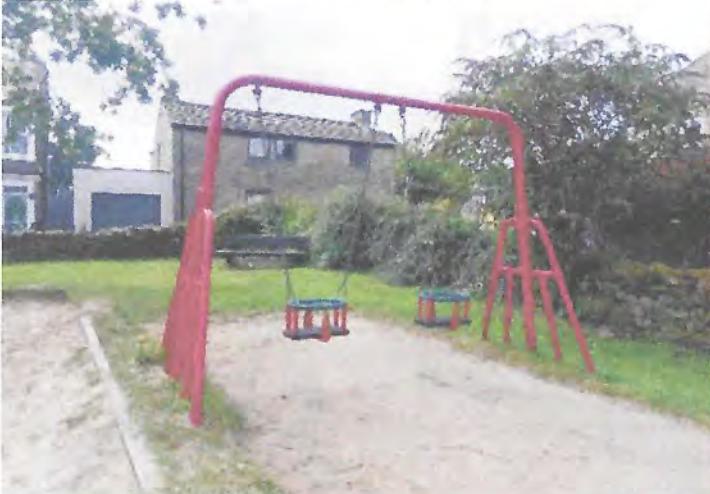
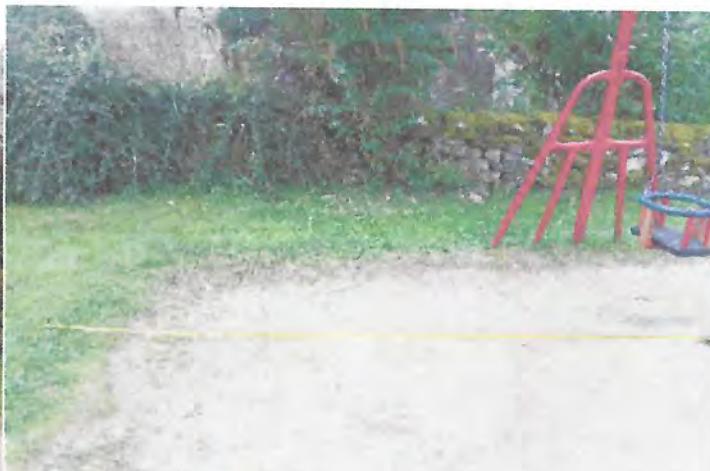
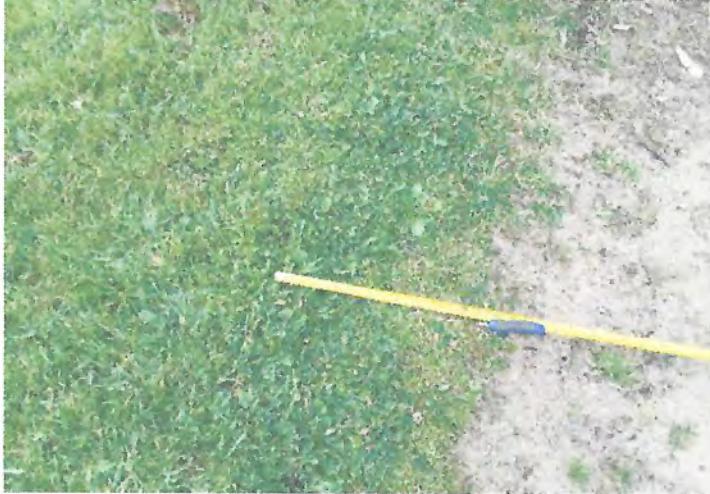
5 - Very Low Risk (Finding 4)	
Item: Swings - 1 Bay 2 Seat (Cradle) Manufacturer: Wicksteed Playgrounds	Risk Level: V - Very Low Risk Surface: Wet Pour

Finding: The surfacing dimensions are short and do not meet with the requirements of the current applicable standard	Action: Monitor - no remedial action recommended
