the play inspection company

Annual Inspection

Pendle Borough Council

Salterforth

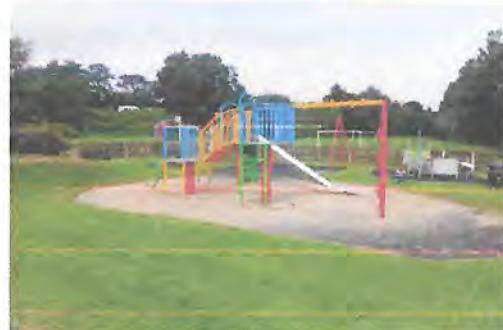
Finding 1

Sand has migrated on to the surfaces - Clean and maintain

There is algae, silt or moss growth on the surface resulting in slippery conditions - Clean and treat appropriately

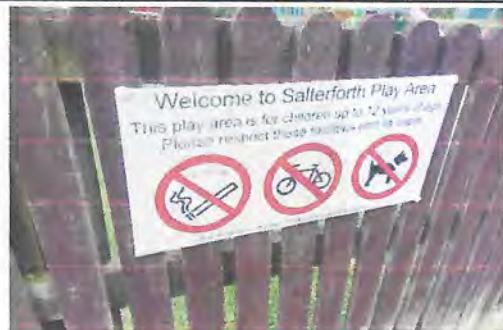
Finding 1

BS EN 1176 Part 7 recommends that signage shall include the site name / address - Provide additional information

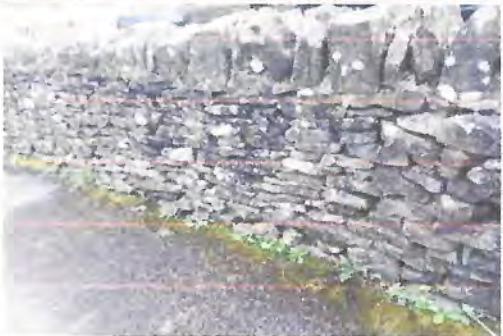
Finding 1
This item is satisfactory - no work required -

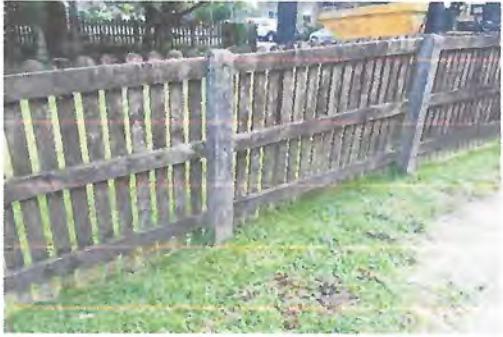
Finding 1
There are a number of loose posts around the fence - Monitor for any further deterioration and reset as required

Finding 2
There are projecting bolt thread(s) present - Remove excess thread length and deburr or provide cap

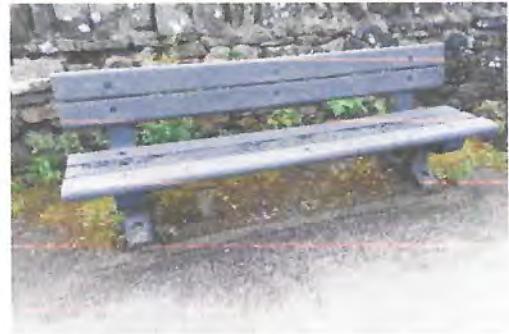
Finding 1

This item is satisfactory - no work required -

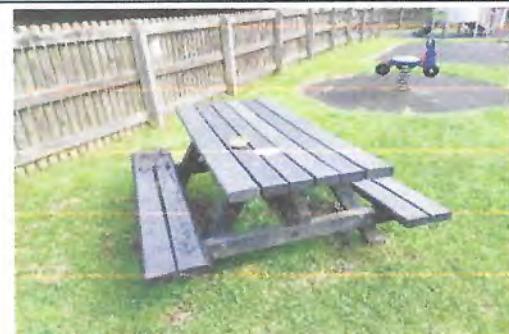
Finding 1

This item is satisfactory - no work required -

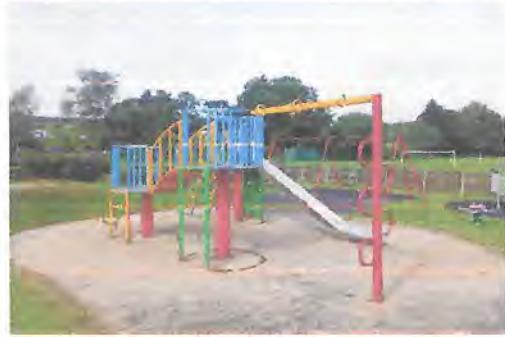
Finding 1

There are a number of dents in the slide surface - Monitor for any further deterioration and repair as required

The connecting links are in excess of 8.6mm and less than 12mm and fail the requirements of BS EN 1176 Part 1; clause 4.2.13, Chains - Monitor use and replace with compliant links at the next maintenance cycle

The paintwork on this item has been damaged or worn exposing the metal underneath which is rusting / corroding - Treat affected areas and repaint

There is/are bolt cap covers missing or damaged on the item - Replace missing or damaged bolt cap covers

The ropes/nets are worn/damaged in places - Monitor for any further deterioration and repair or replace as required

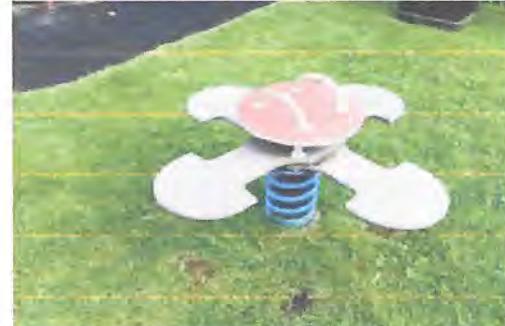
Finding 1

This item is satisfactory - no work required -

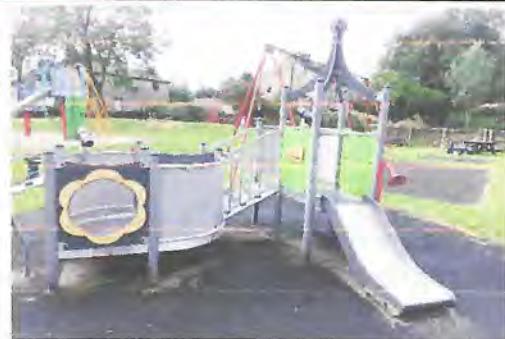
Finding 1

There are gaps opening between the surfacing and the edging surround or between the joints in the surfacing - Monitor for any further deterioration and repair as required

The item has been damaged - Monitor for any further deterioration and replace as required

There is/are bolt cap covers missing or damaged on the item - Replace missing or damaged bolt cap covers

A number of fixing(s) have worked loose - Secure all loose fixings

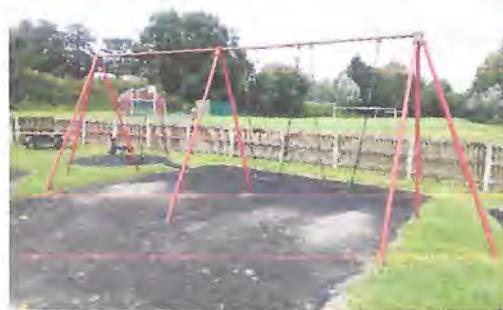
Finding 1

The bushes are worn or missing - Replace worn or missing bushes

There is some notable evidence of chain wear - Monitor for any further deterioration and replace when 40% worn

The chain openings are in excess of 8.6mm and do not meet the recommendations of BS EN 1176 Part 1 - Monitor - No remedial work recommended

There is some wear to the shackles - Monitor for any further deterioration and replace when 40% worn

The seat has minor damage or wear - Monitor for any further deterioration and replace as required

The seats are too close to each other as defined in BS EN 1176 Part 2; this is a low risk failure and no remedial action is required - Monitor - No remedial work recommended

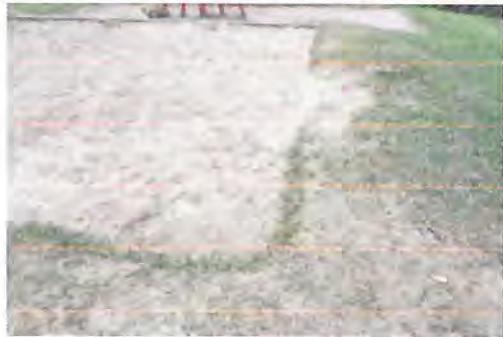
Finding 1

This item is satisfactory - no work required -

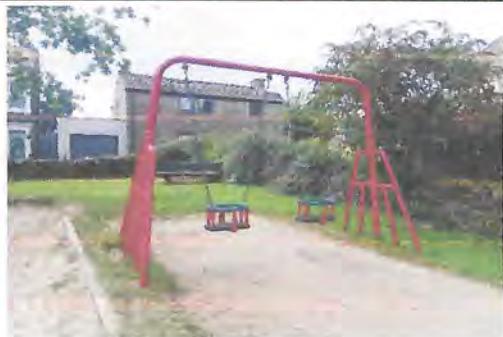
Finding 1

The bushes are showing signs of wear - Monitor for any further deterioration and replace as required

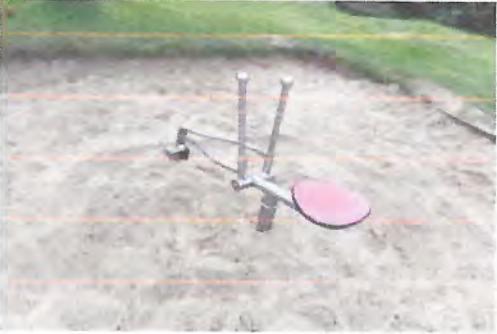
Finding 1
This item is satisfactory - no work required -

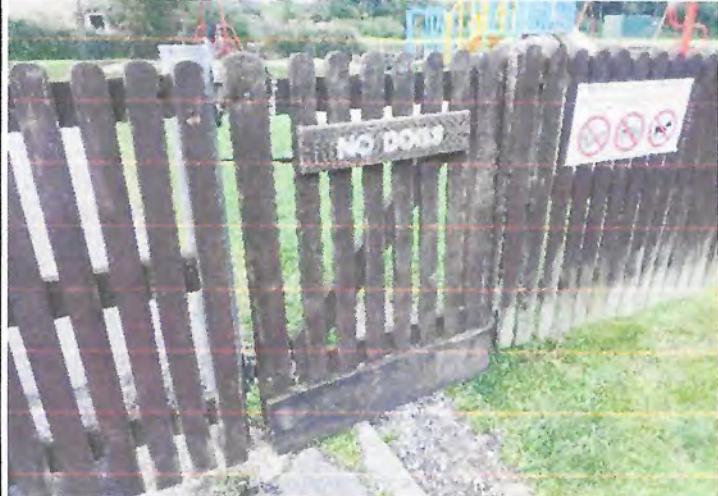
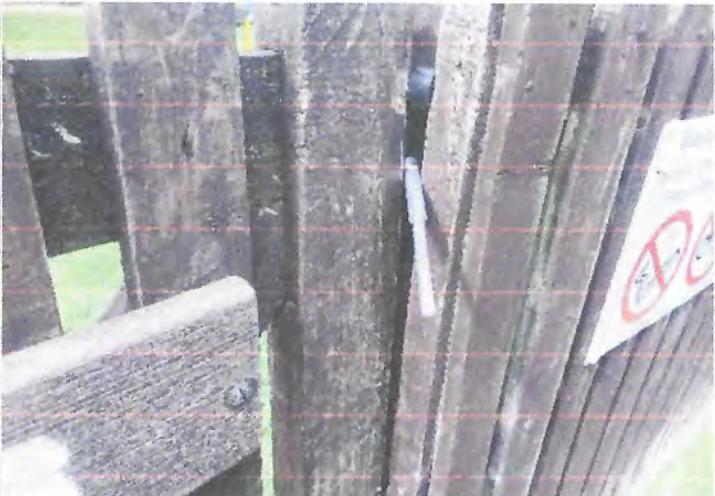
Finding: There are openings that are less than 12mm that could trap or crush fingers

Action: Provide a 12mm gap throughout full range of motion at both sides of gate

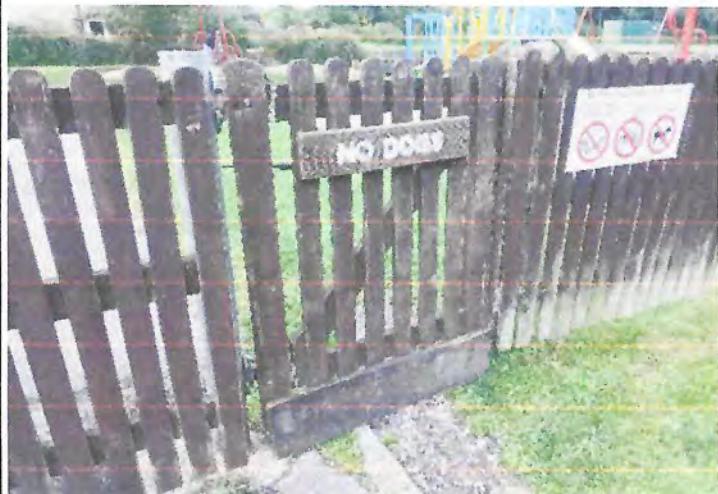
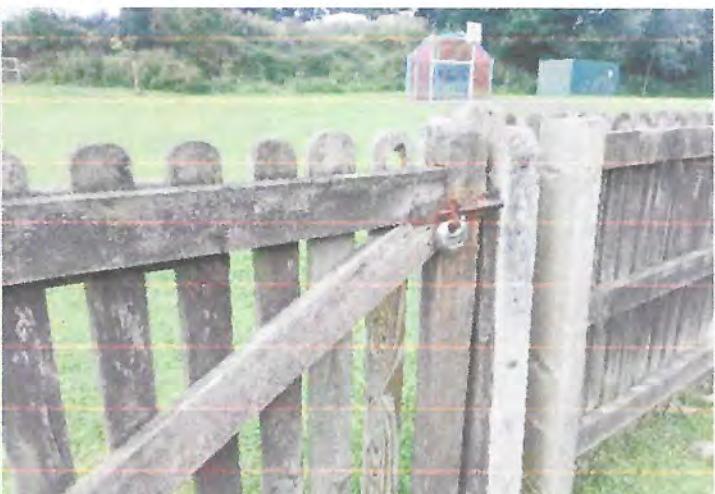
Finding: The gate/s was / were locked or secured at the time of the inspection and a full inspection could not be undertaken

Action: Complete inspection of gate/s when re-opened

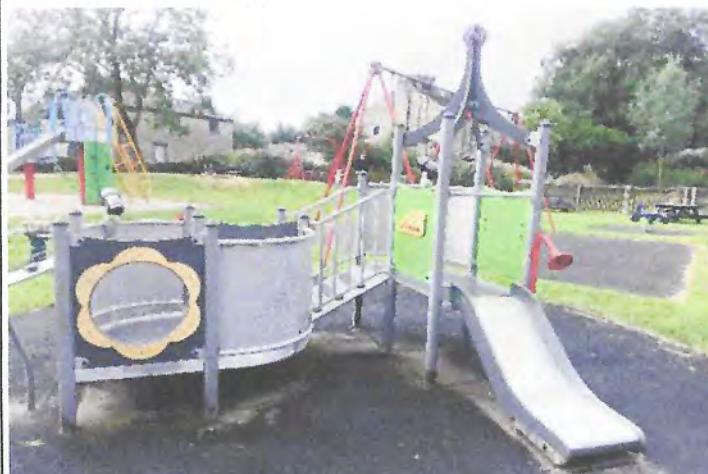
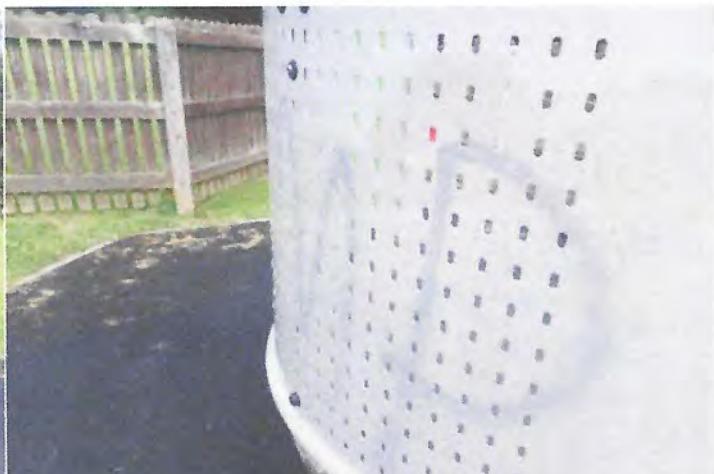
Finding: There is some graffiti present

Action: Remove the graffiti

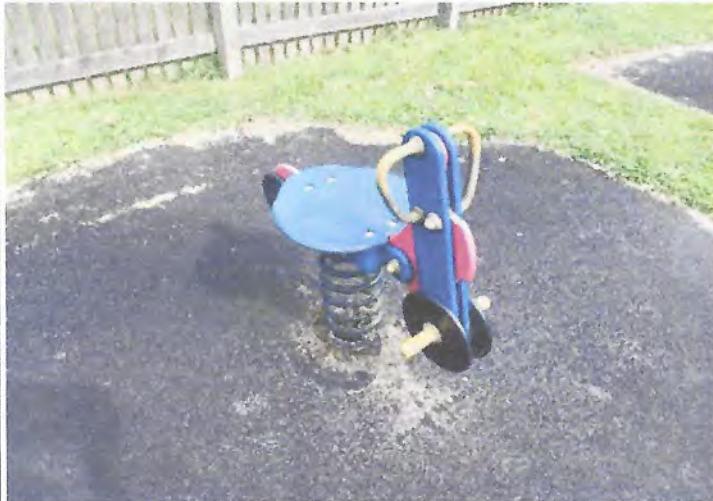
6 - Low Risk (Finding 4)

6 - Low Risk	
Item:	Spring Bike
Manufacturer:	Ledon
Surface Type:	Wet Pour
Item Quantity:	1
Equipment Compliance:	No
Surface Area Compliance:	Yes
Life Expectancy:	5 -10 Years
Total Findings:	4
Finding 1	Finding 2
The end of handgrips and/or footrests have a cross section of less than 15cm ² and fail to meet the requirements of BS EN 1176 Part 6 - Monitor - No remedial work recommended	The U bolts clamping the spring are worn - Monitor for any further deterioration and replace as required
Finding 3	Finding 4
The paintwork on the spring has been damaged or worn exposing the metal underneath which is rusting - Treat any rusting components and repaint	The footrest has been damaged - Monitor for any further deterioration and replace as required

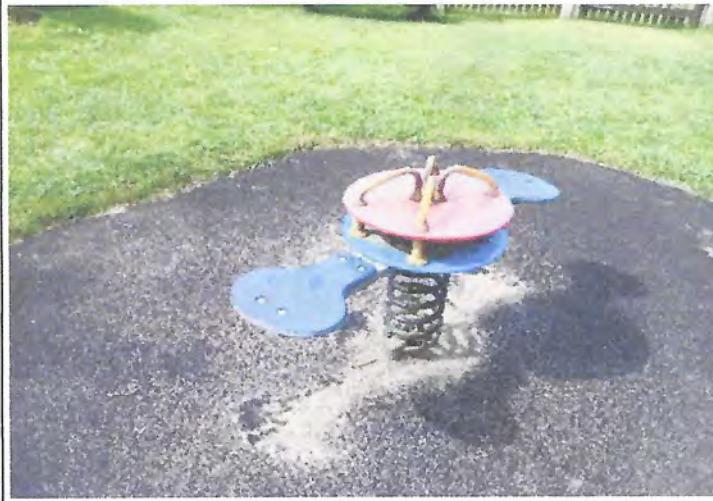
4 - Very Low Risk (Finding 1)

4 - Very Low Risk	
Item:	Spring See-Saw
Manufacturer:	Fahr Industries
Surface Type:	Wet Pour
Item Quantity:	1
Equipment Compliance:	Yes
Surface Area Compliance:	Yes
Life Expectancy:	5 -10 Years
Total Findings:	1
Finding 1	
The U bolts clamping the spring are worn - Monitor for any further deterioration and replace as required
